## INVESTIGATIONS WITH REINFORCED CONCRETE TOMOGRAPHY

M. A.J. Mariscotti, P. Thieberger,  
T. Frigerio, F. Mariscotti and M. Ruffolo  
THASA  
Reclus 2017, 1609 Boulogne, BA  
Argentina  
[mariscotti@thasa.com](mailto:mariscotti@thasa.com)

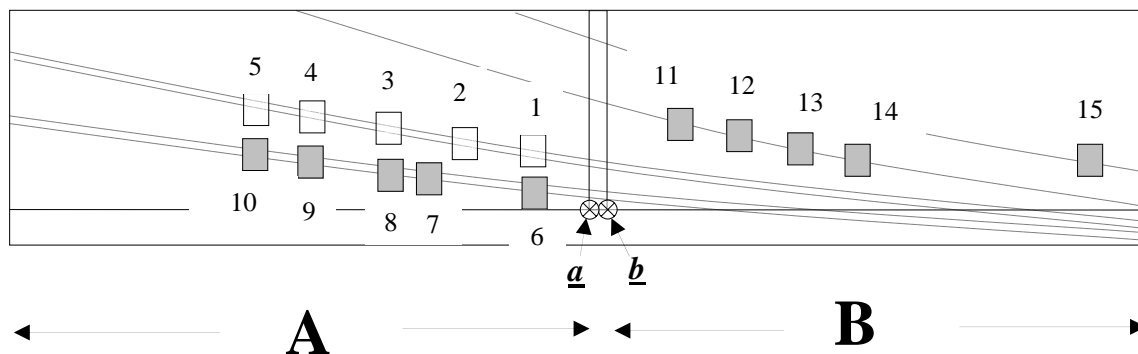
Fig. 4. The dotted lines indicate the ducts and the rectangles show the (approximate) positions of the plates obtained in these measurements. Source-plate arrangement in 1 to 5 was opposite to that in 6 to 15.

Another case of faulty grouting was observed in position 13 (Fig. 4) and plate 3 revealed honeycombing in the concrete matrix, below the ducts. This work also provided data on the number, position, diameter and condition of 12 mm stirrups (seen in Fig. 5 as vertical white bands).

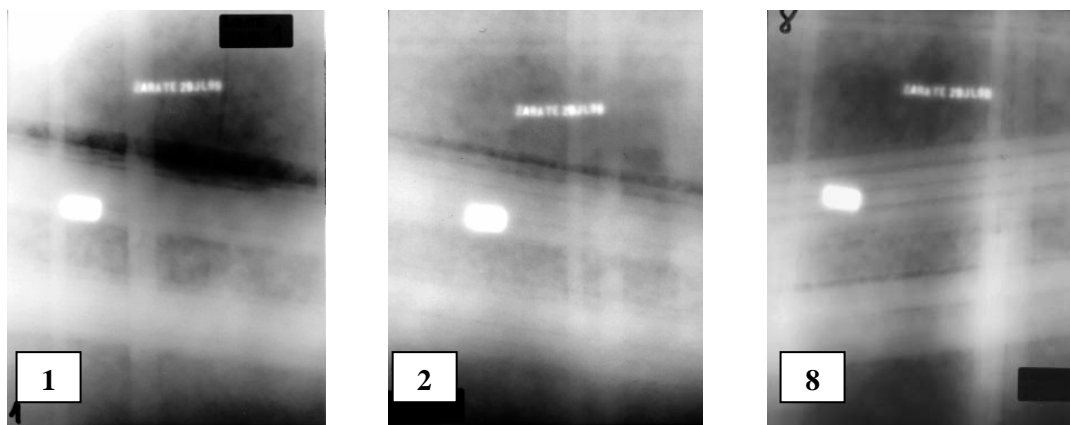
Fig. 5. Gammagraphies at locations 1, 2 and 8 in Fig. 4. Plate No. 1 shows a marked void in the upper duct for lack of grouting (dark band). This defect diminishes toward the left in Fig. 4 and is barely visible in Plate No. 2. Plate No. 8 does not show any sign of defect in the grouting. This gammagraphy also shows that the condition of the individual wires is good.

In total 15 locations, shown in Fig. 4, corresponding to 4 different ducts were studied with a  $93\text{ Ci }^{192}\text{Ir}$  source. At location 1 a severe void was found (Fig. 5 (1)) on the upper part of the upper duct (seen as a black thick line). This fault is seen to diminish toward the left in Fig. 4 and is barely seen in plate 2 (Fig. 5 (2)) as a thin black line on the upper part of the upper duct. In the other locations the gammagraphies revealed no defects as can be seen in plate 8 (Fig. 5 (8)). The quality of the latter is good enough to allow assessment of the individual wires, which in this case do not exhibit any corrosion.

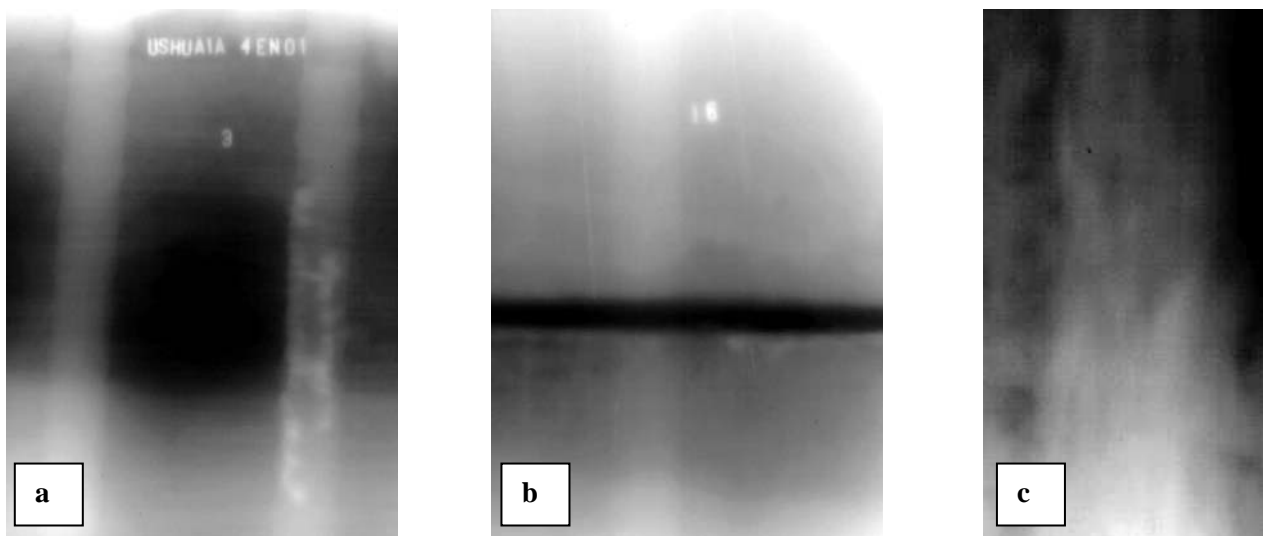
Fig. 7. a) A plate obtained at sea level showing two 32 mm rebars. The one on the right is damaged with incrustations and corrosion; b) A plate obtained at about 30 cm above the seabed, showing a crack in the steel sleeve; c) Case of corrosion with part of the bar vanished.

In this work systematic cracks in the steel sleeves of the pillars at about 30 cm above the seabed and several cases of corroded rebars were found (Fig. 7).

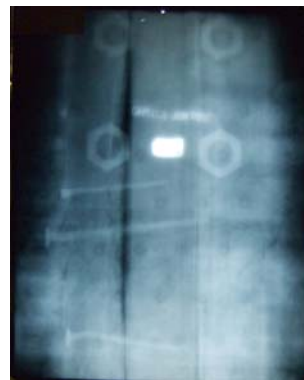
Fig. 11. Sample of plate obtained in this work with source at the center.

Fig. 11 shows one of the gammagraphies obtained during this work taken with the source at the center. The 3 adjacent logs are seen. The first and second from the left of Fig. 11 show some separation that gives rise to a black vertical line. The image of nuts, a white rectangle and a label are due to external references. A few XVII century nails (unexpected by the experts) are also seen. A careful calibration of photographic

The high point corresponding to the horizontal coordinate 13 cm in Fig. 12 corresponds to the black vertical line showing a small gap between the first and second log from the left in Fig. 11. The analysis shows that the depth of this gap is  $15 \pm 2 \text{ cm}$ . The deviation between measured and calculated data towards the left of the plot in Fig. 12 corresponds to a lack of material  $L$  in the path of the gamma-rays equal to  $L = (5 \pm 1) \text{ cm}$ .

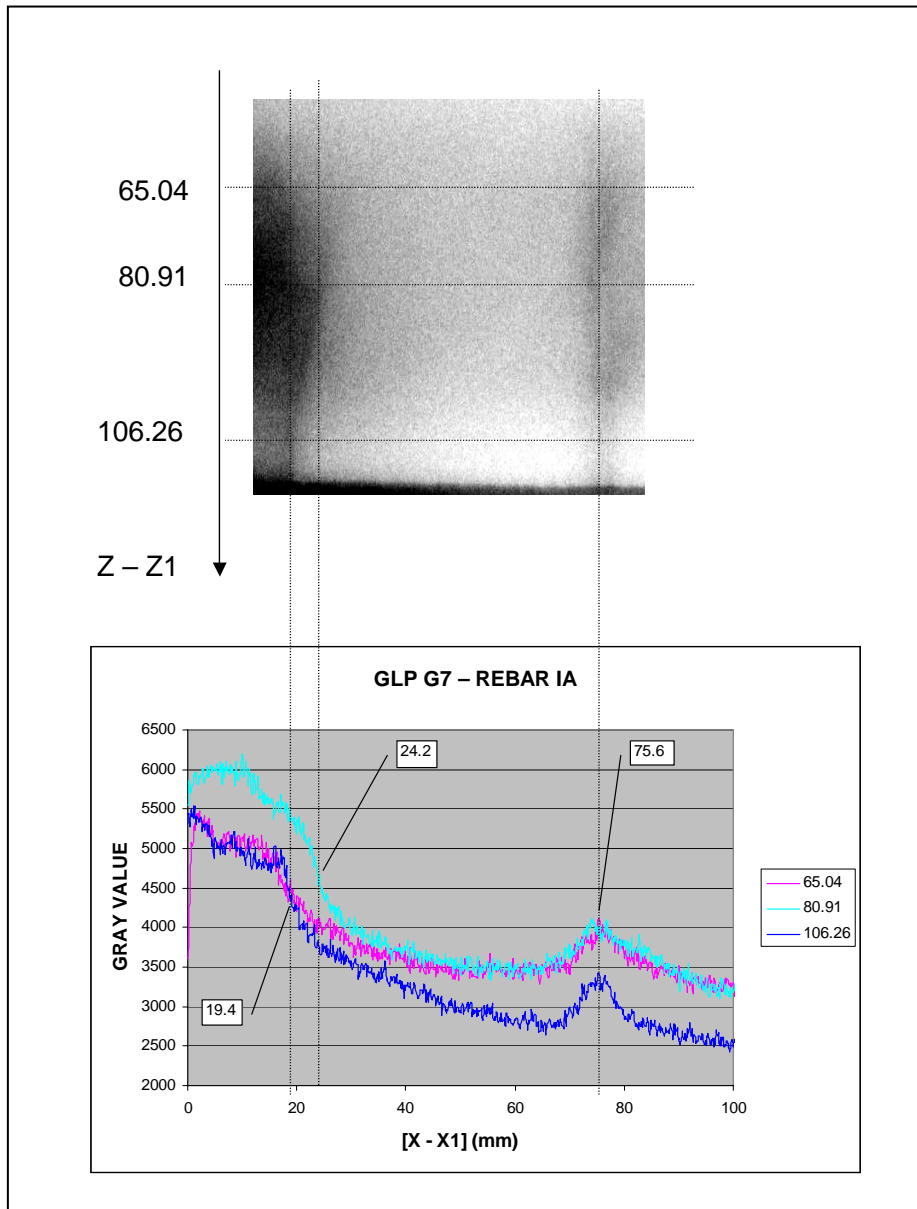
Fig. 15. Density  $D$  distributions for one of the scissor bars (IA#7). The light blue data points correspond to the notch seen on the left of the gammagraphy above. The difference at the point of maximum slope with the data in magenta and blue is 4.8 mm that corresponds to a notch size in the real bar of  $(2.4 \pm 0.2)$  mm.

shown in Fig. 15 where gray values (in this case equivalent to  $D$  photographic density values) in a gammagraphy are plotted as a function of position along an axis transversal to the rebar main axis  $Z$ , for 3 values of  $Z$ . The case shown here corresponds to one of the rebars where a notch is clearly visible (gammagraphy in the upper part). A precise determination of the size of this notch is obtained by

comparing  $D$  distributions corresponding to different sections of the rebar. The light blue data points correspond to the section where the notch seen on the left of the gammagraphy above is largest. The difference at the point of maximum slope with the data in magenta and blue is 4.8 mm, which corresponds to a notch size in the real bar of  $(2.4 \pm 0.2)$  mm. In this work two notches like this one in a plane perpendicular to the radiation were well established. Determination of defects on a plane parallel to radiation is less straightforward. A lack of steel within a narrow radiation cone that passes through the center of the rebar will manifest itself as a “bump” in the center of the “valley-shaped”  $D$  distribution, such as those in Fig. 15. The amount of steel thickness equivalent that such a bump represents can be determined with the use of GAMMASIM. However, in this case more than one exposure is necessary to establish whether such a bump is due to corrosion in the steel or to a small void in the concrete material anywhere between source and plate within the radiation cone.
