Gamma-ray imaging for void and corrosion assessment in PT girders

M.A.J. Mariscotti^a, F. Jalinoos^b, T. Frigerio^a, M. Ruffolo^a and P. Thieberger^a

As an extension of the reinforced concrete tomography technique, gamma rays have been successfully applied for the assessment of voids and corrosion in concrete structures. In this paper, some examples are given that illustrate the advantages of using this technique, especially in the case of PT girders. Results obtained in the Zárate bridge in Argentina are discussed in some detail.

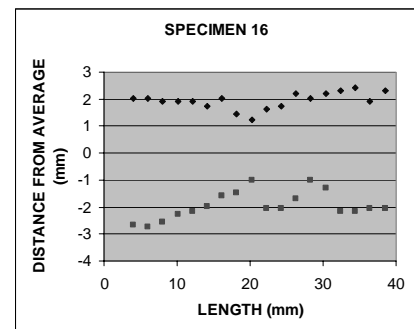
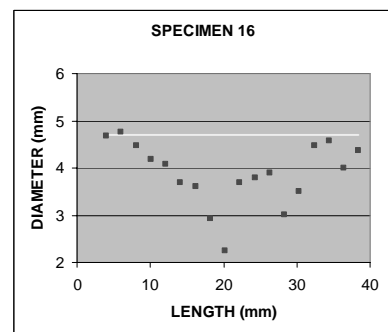
The upper part of Fig. 1 shows the gammagraphy of a corroded rebar [5]. The effect of corrosion in a rebar is to change metal into oxide, the latter being of less density. The absorption of gamma rays, being sensitive to density will show the loss of metal in a gammagraphy as a change of rebar diameter. Since the amount of corrosion varies along the rebar length, the phenomenon is seen in a gammagraphy as a change of diameter at different sections.

The plots in Fig. 1 show the edge pixel positions in terms of distance to the “average center” of the bar (upper plot) and their differences (lower plot), along the length of the bars.

The data in the lower plot correspond to the defects in the projected diameters relative to the expected value (white straight line). The accuracy of this measurement is estimated at 0.3 mm.

Fig. 1. Gammagraphy of a corroded bar in a concrete block [5]. The plots show the edge pixel positions in terms of distance to the “average center” of the bar and their difference, along the length of the bars.

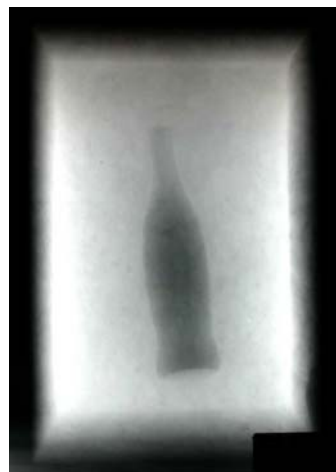
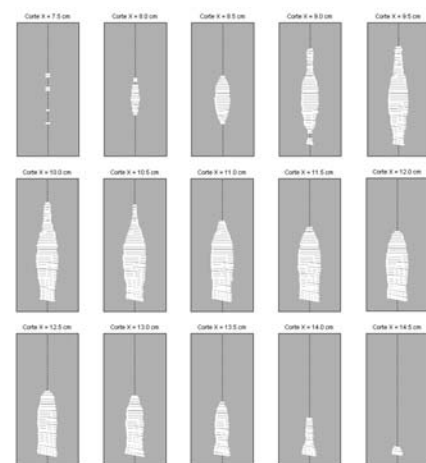
Likewise voids in concrete can also be precisely ascertained. The left hand side of Fig. 2 shows the gammagraphy of a concrete block with an artificially generated void of a well known shape inside, that exhibits the extension of the void in the plane perpendicular to the radiation, while the plots on the right hand side corresponds to the “depths” of the void in the different planes parallel to radiation, obtained with 1 cm³ gamma-ray spectrometer.

Fig. 2. Example of void determination with gamma-rays. The left hand side shows a gammagraphy of an empty Coca Cola bottle (a universally recognized shape) which exhibits the extension of the void in the plane perpendicular to the radiation, while the plots on the right hand side corresponds to the “depths” of the void in the different planes parallel to radiation, obtained with 1 cm³ gamma-ray spectrometer.

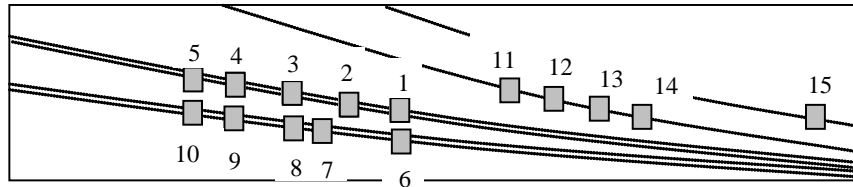
Fig. 4. Schematic location of the gammagraphies taken in this work

One of the 30 cm (1ft) thick girders at the West end of the bridge (left in Fig. 3) with a total of 6 ducts was inspected for voids in the grouting using gamma-rays from a $^{93}\text{Ci } ^{192}\text{Ir}$ source. Gammagraphies were taken in the positions indicated in Fig. 4. As a reference, distance between 1 and 2 is 70 cm (2.5 ft).

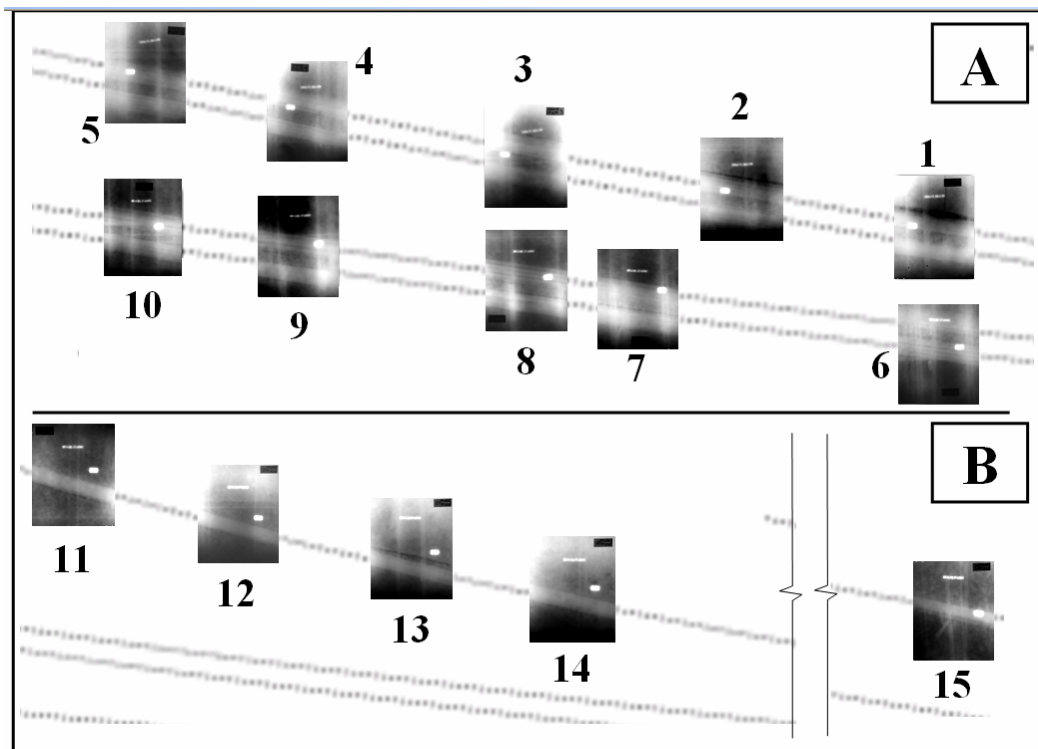
Fig. 5. Overview of the gammagraphies obtained in this work. Frame B corresponds to the right part of the girder (see Fig. 4). As discussed in the text, gammagraphies 1, 2, 3 and 13 exhibit defective grouting, most notably in 1.

Fig. 5 gives an overview of the 15, 35 x 43 cm (14"x 17") gammagraphies obtained in this work and Fig. 6 exhibits enlargements of four of these gammagraphies for the purpose of the following discussion.

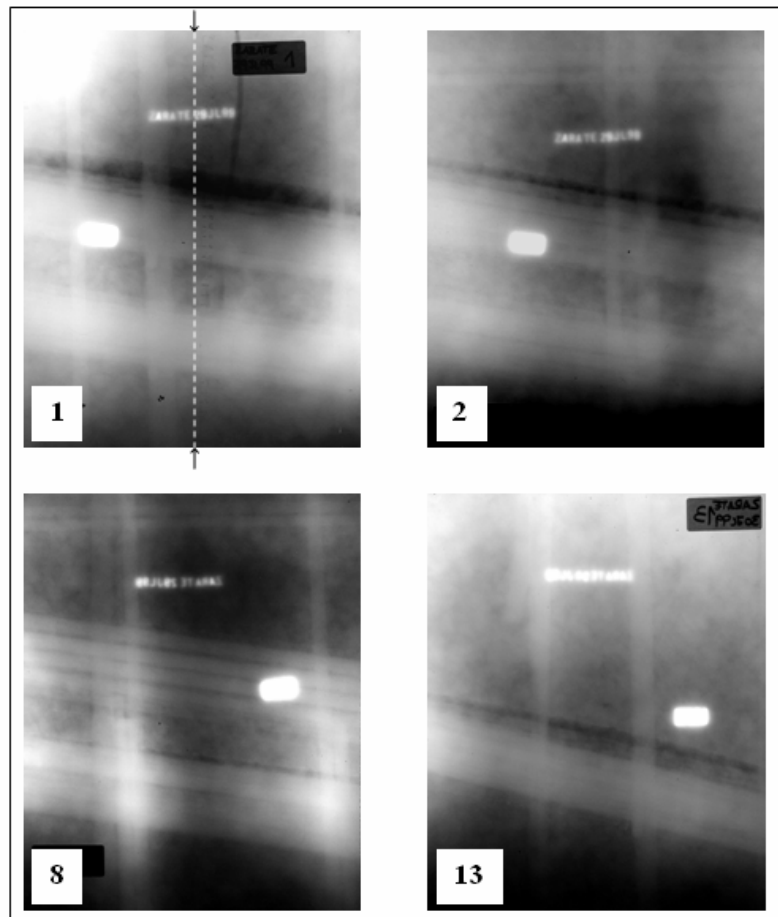
Fig. 6. Illustrative examples of the measurements carried out in Zárate bridge. Gammagraphy 1 shows a severe case of void in the grouting of the upper duct. In 2, which is the next gammagraphy towards one of the ends of the girder, this defect is still present but diminished. In the upper duct in 8 the different bundles of wires can be appreciated and in both the lower duct of 8 and upper duct of 13 thin black lines show slight voids. These gammagraphies also show stirrups as white vertical bands. The cables and ducts diameters are ~2" and 3", respectively.

Gammagraphy 1 shows a severe case of void in the grouting of the upper duct. In 2, which is the next gammagraphy away from the center of the girder, this defect is still present but less marked than in 1. Also minor voids in the upper part of ducts in gammagraphies 8 and 13 are discernible.

These voids can be analyzed quantitatively in order to assess their size. As an example, we shall discuss the case of gammagraphy 1.

The following conclusions can be drawn from these results: a) At the maximum photographic density, the depth of the void is a little more than 6 cm equivalent to about 5 cm of air since the fitted density in this volume is 0.3 g/cm^3 ; b) Considering that the maximum density of a cable composed of bundles of steel wires is about 80% of steel density, then the fitted density of 3.5 g/cm^3 indicates that the cables packing factor is about 55%; c) The difference between calculated and measured values at $Z \sim 25$ cm corresponds to a steel thickness deficiency in the top wires of the upper duct of up to 7 mm.

In the other gammagraphies shown in Fig. 6 no steel thickness deficiency signaling corrosion has been observed beyond the measurement uncertainty of 0.3 mm.

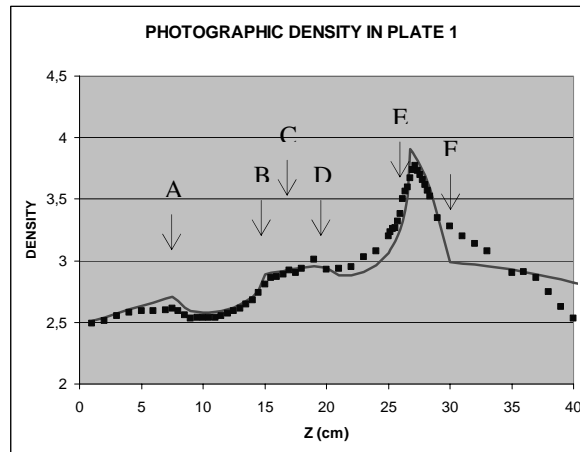
Fig. 7 shows the photographic density along the vertical dotted line in Fig. 6 (plate 1). The coordinate Z goes from the bottom up in the gammagraphy as shown in Fig. 6. “Valleys” in this plot at $Z \sim 10$ and 22 cm correspond to the lower and upper ducts, respectively and the peak at ~ 27 cm correspond to the void in the grouting of the upper duct.

Fig. 7. Photographic density along dotted line in plate 1. A-B: lower cable; A-C lower duct; D-E: upper cable; D-F: upper duct (see Fig. 6)

These data were fitted (gray line) to the mathematical expression that describes the experimental arrangement used in these measurements: Gamma-rays from an ^{192}Ir source at 60 cm from the plate traversing a 2.5 g/cm^3 concrete block with two 7.2 cm internal diameter ducts in the center of the block, both with 5.2 cm diameter cables inside. The only significant adjustable parameters in this calculation were: the grouting density in the upper duct (0.3 g/cm^3) and the density of both cables (set to 3.5 g/cm^3). The grouting density in the lower duct was assumed equal to that of concrete.
