## INVESTIGATIONS WITH REINFORCED CONCRETE TOMOGRAPHY

M. A.J. Mariscotti, P. Thieberger,  
T. Frigerio, F. Mariscotti and M. Ruffolo  
THASA  
Reclus 2017, 1609 Boulogne, BA  
Argentina  
[mariscotti@thasa.com](mailto:mariscotti@thasa.com)

### ABSTRACT

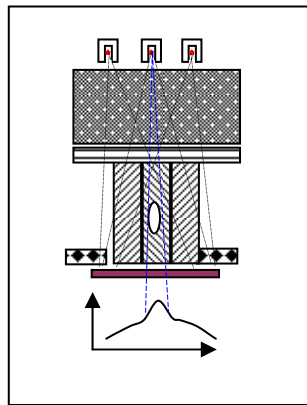
Fig. 10. Section view of the roof

Fig. 10 is a cross section view of the roof showing the 3 source positions (little squares at the top) used for examining each set. The upper area represents the tiles; below the tiles rest the sheathing boards and directly beneath are the beams. The thick brown line underneath the beams is the gammagraphic plate. The schematic plot at the bottom in Fig. 10 illustrates the expected intensity distribution along an axis on the plate if a cavity as that shown in the central log in Fig. 10 was present.
