Gamma-Ray Imaging for Void and Corrosion Assessment

Safety and utility of the technology make it appropriate for field application

BY MARIO A.J. MARISCOTTI, FRANK JALINOOS, TERESITA FRIGERIO, MARCELO RUFFOLO, AND PETER THIEBERGER

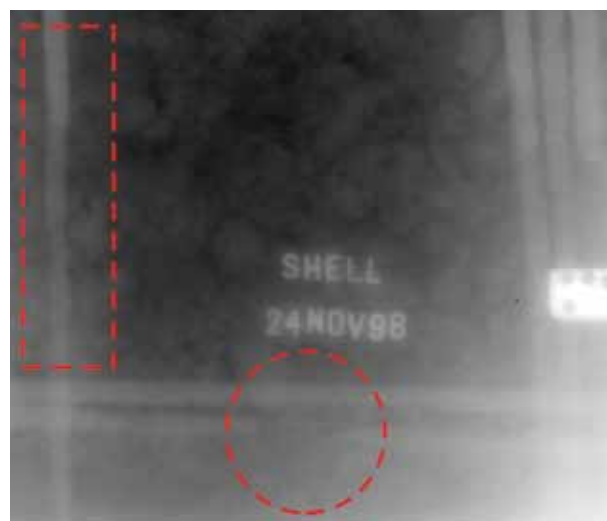
Fig. 4: Severely corroded reinforcing bars

Figure 4 shows part of a gammagraphy obtained with a conventional film: a double grid of nominal 8 mm (0.3 in.) diameter bars near the top of a 200 mm (8 in.) thick concrete wall of a refinery tank. The concrete cover is about 400 mm (16 in.) for both grids (distance to nearer wall face). The effect of corrosion in reinforcing bars is to change metal into oxide, the latter being less dense. The absorption of γ-rays, being sensitive to density, will show the loss of metal in a gammagraphy as a change of bar diameter. Because the amount of corrosion varies along the bar length, the phenomenon is seen in a gammagraphy as a change of diameter at different sections.

The gammagraphy of Fig. 4 shows severe corrosion defects, including a section (in the red circle) of reinforcing bar that's disappeared. The following analysis is related to the segment of reinforcing bar highlighted by the red rectangle in Fig. 4. This segment is shown in Fig. 5(a), rotated 90 degrees counterclockwise. A quantitative analysis of the extent of the corrosion in terms of loss of bar section can be done by plotting the position of "edge" pixels along an axis parallel to the bar. Edge pixels define the bar profiles and correspond to the points of maximum slope in the gray level distribution along an axis perpendicular to the bar's main axis for each section. The maximum slope can be found by software methods.¹³
