## INVESTIGATIONS WITH REINFORCED CONCRETE TOMOGRAPHY

M. A.J. Mariscotti, P. Thieberger,  
T. Frigerio, F. Mariscotti and M. Ruffolo  
THASA  
Reclus 2017, 1609 Boulogne, BA  
Argentina  
[mariscotti@thasa.com](mailto:mariscotti@thasa.com)

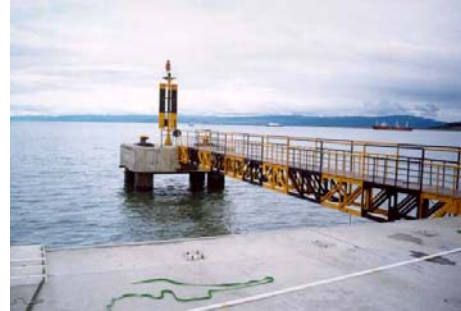
Fig. 6. A view of the Dolphin in Ushuaia harbor.

This structure had sustained the collision of a big ship against its South East corner. Thus, after this event THASA was commissioned to undertake an investigation on the condition of the pillars (possible cracks and damaged reinforcement) both at sea level and near the seabed.

In this work systematic cracks in the steel sleeves of the pillars at about 30 cm above the seabed and several cases of corroded rebars were found (Fig. 7).

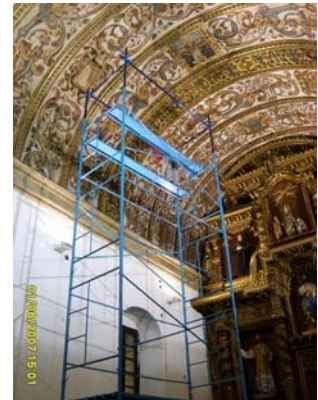
Fig. 8. View of the ceiling of the chapel

Termite-produced fist-size cavities were found in the sheathing boards and beams under the tiles when, because of signs of moisture in the ceiling, tiles were removed in a small section near the front left corner of the roof.

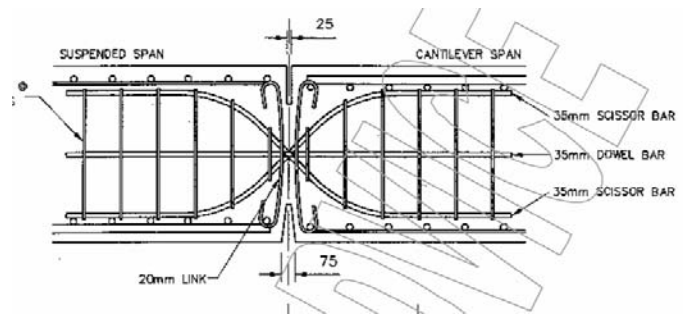
There are more than one hundred bridges in the UK on the trunk road and motorway network with concrete hinges (Fig. 13) in their decks. Scissor and dowel bars at the crossing point in the hinge are particularly vulnerable to corrosion in the event of bridge deck waterproofing failure. In this connection the UK Highways Agency (HA) has implemented a program to investigate various non destructive techniques to establish their ability to detect corrosion and for this purpose commissioned the Transport Research Laboratory (TRL) to construct (Badr et al., 2006) a full size mock-up of a hinge with embedded defects (Fig. 14).

Fig. 13. Typical hinge detail showing the 2 scissor and 1 central dowel bars crossing at the center of the hinge.

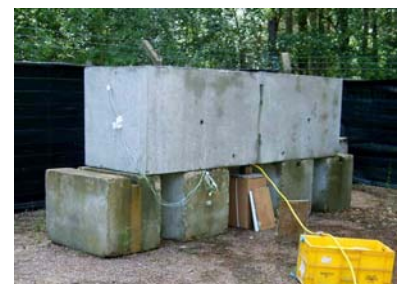
Fig. 14. View of the hinge specimen prepared by TRL

In collaboration with Atkins (Vassou, 2005, SSR, 2006), THASA carried out measurements on this full-scale specimen (Fig. 14) to test whether RCT technology could effectively detect corrosion-like defects in the scissor and dowel bars at the center of the joint.

The specimen was 88 cm wide containing 3 sets of scissor and dowel bars with various hidden defects. As a first step the top of the specimen was swept with a covermeter to approximately locate these
