Gamma-ray imaging for void and corrosion assessment in PT girders

M.A.J. Mariscotti^a, F. Jalinoos^b, T. Frigerio^a, M. Ruffolo^a and P. Thieberger^a

As an extension of the reinforced concrete tomography technique, gamma rays have been successfully applied for the assessment of voids and corrosion in concrete structures. In this paper, some examples are given that illustrate the advantages of using this technique, especially in the case of PT girders. Results obtained in the Zárate bridge in Argentina are discussed in some detail.

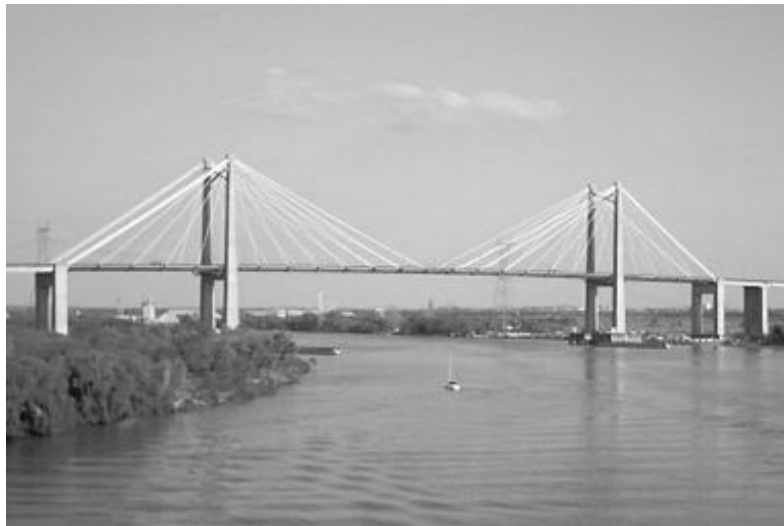
An inspection of a PT girder was carried out in the Zárate bridge (Fig. 3). This is a two cable-stayed road and railway bridge in Argentina, crossing the Paraná River between the Buenos Aires and Entre Ríos provinces. The bridge has a suspended length of 550 m (1,804 ft), with a main span of 330 m (1,083 ft). Its pylons are 110 m (361 ft) high, and its deck depth is 2.6 m (8.5 ft). It was built between 1972 and 1978 on a design by Italian engineer Fabrizio de Miranda, and refurbished in 1998. The road link has four lanes. The main span is 50 m (164 ft) over the water level of the Paraná, which allows the passage of very large ships

Fig. 3. View of the Zárate Bridge in Argentina
