## INVESTIGATIONS WITH REINFORCED CONCRETE TOMOGRAPHY

M. A.J. Mariscotti, P. Thieberger,  
T. Frigerio, F. Mariscotti and M. Ruffolo  
THASA  
Reclus 2017, 1609 Boulogne, BA  
Argentina  
[mariscotti@thasa.com](mailto:mariscotti@thasa.com)

### ABSTRACT

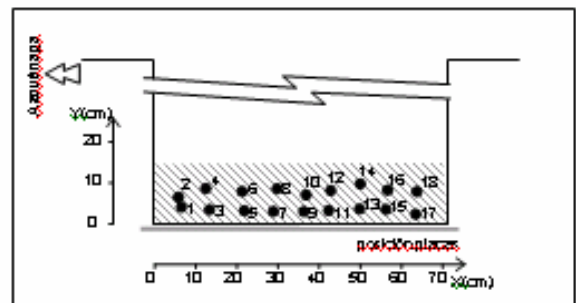
Fig. 1. RCT results for a beam 70 cm wide obtained with a  $^{192}\text{Ir}$  source.

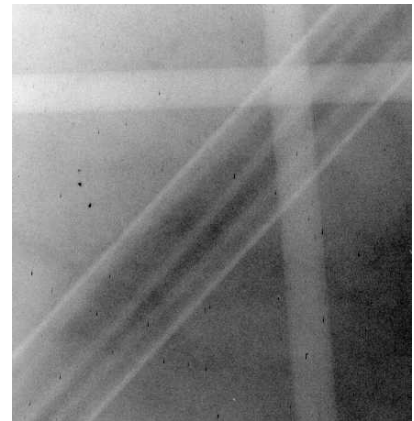
Fig. 2 Details of an electrical conduit in a slab with cables inside illustrate the sensitivity achievable with RCT.

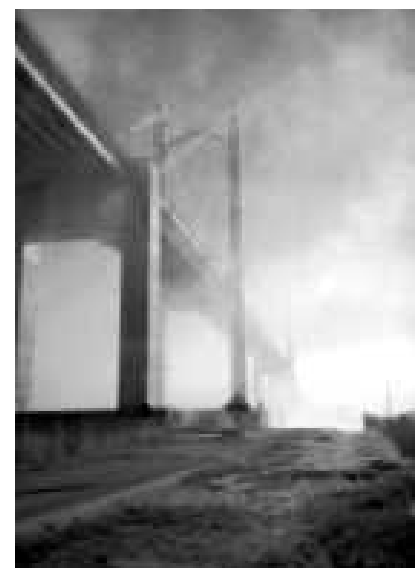
Fig. 3. Zarate-Brazo Largo bridge complex in the limit between Buenos Aires and Entre Ríos.

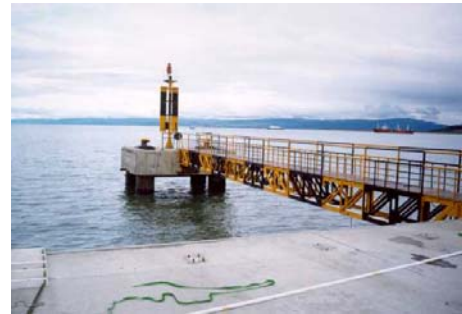
This structure had sustained the collision of a big ship against its South East corner. Thus, after this event THASA was commissioned to undertake an investigation on the condition of the pillars (possible cracks and damaged reinforcement) both at sea level and near the seabed.

Fig. 6. A view of the Dolphin in Ushuaia harbor.

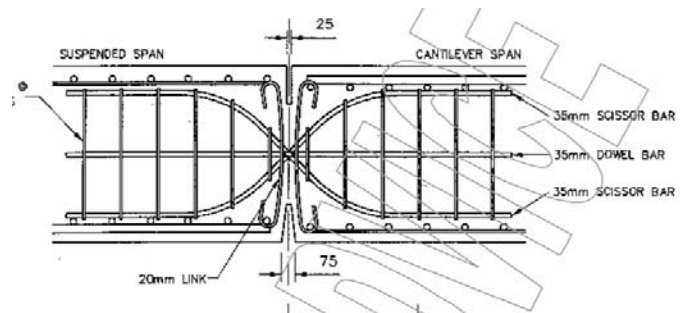
There are more than one hundred bridges in the UK on the trunk road and motorway network with concrete hinges (Fig. 13) in their decks. Scissor and dowel bars at the crossing point in the hinge are particularly vulnerable to corrosion in the event of bridge deck waterproofing failure. In this connection the UK Highways Agency (HA) has implemented a program to investigate various non destructive techniques to establish their ability to detect corrosion and for this purpose commissioned the Transport Research Laboratory (TRL) to construct (Badr et al., 2006) a full size mock-up of a hinge with embedded defects (Fig. 14).

Fig. 13. Typical hinge detail showing the 2 scissor and 1 central dowel bars crossing at the center of the hinge.
